The Lodge at Camp Tecumseh

Heather Corrigan Internship Summer 2015 Plymouth State University

Internship at Camp Tecumseh

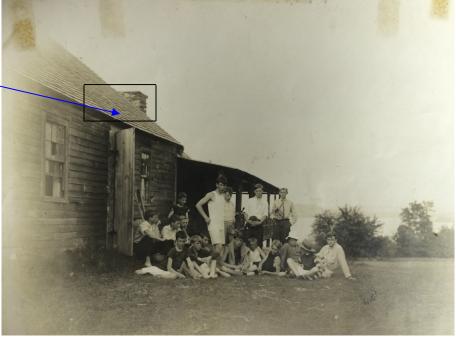
Figure 3: Facing historic tennis courts, un-numbered

Chimney added for large fireplace, camp addition c.1905

- *Lodge was being used for dining and assemblies during inclement weather
- *Enrollment in camp doubled in the two years since the camp's establishment; dining on the porch still existed, but needed more space for the growing enrollment
- *Additions of the two side porches and expansion of the porch facing the lake
- *Central chimney in Figure 3 for kitchen which was housed in building

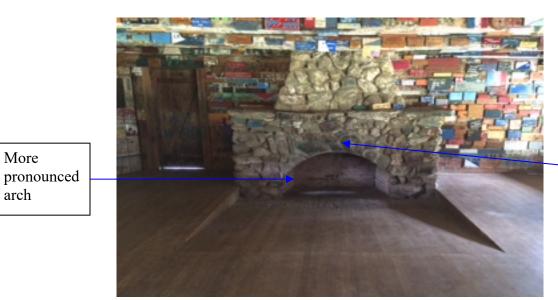
Figure 5: current view of fireplace, photo by author

arch

*Arch on current fireplace has definite curve, height lower than historic fireplace, re-faced at some time, dates unknown

Pattern of rocks differs from 1907 picture above

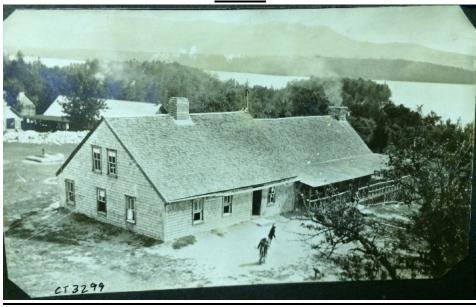
Figure 8: Aerial view of Lodge, CT3299

- *"Double hung sashes" have been replaced with 2x2 double hung sashes from earlier 6x6 double hung window sashes (refers to the 2 pieces which make up the entire window, 2x2/6x6 is the number of panes in each of the window pieces.)
- *Bell is still present at meeting site of buildings
- *Background of photograph shows the camp's growth in just nine years with the addition of the dining hall and other buildings
- *Appearance of Lodge has vastly improved over the years, with replacement of windows, shingles, clapboards around side door and painting of trim

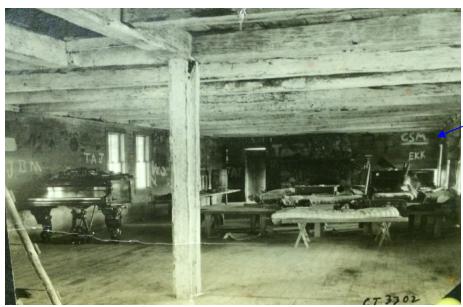
Figure 9: Interior of the Lodge, CT3302

First
appearance of
campers
writing their
names or
initials on the
walls, a time
honored
tradition

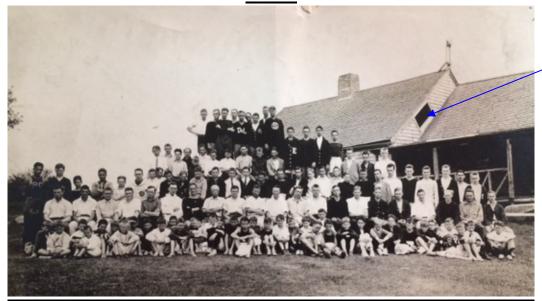
Mysterious "witch window," in gable of original farmhouse

Figure 10: Group photograph, exterior of Lodge, un-numbered *"Witch window," or "coffin window," mysteriously appears in the mid nineteen teens, folklore states they existed in New England, mostly Vermont, and were called "witch windows" because people believed witches couldn't fly through a tilted window⁴

*Folklore also calls them "coffin windows," either because they were shaped as such or because steep, narrow staircases in early homes did not allow coffins to be brought down stairs, instead they had to be taken out the window onto the roof

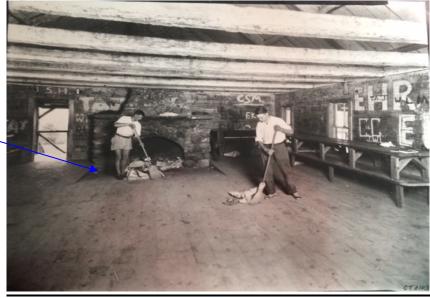
Figure 12: Interior of Lodge, campers sweeping new floor, CT0103

Slanted floor present c.1915

*The floor was raised c.1915 to join the original farm house portion to the Poor Farm portion around this time. Instead of the two buildings having their own identities, they were now joined as one marking the importance of the building to the camp and how the Lodge was creating its own history apart from the farm house and Poor Farm that once inhabited it.

*The photograph shows two campers sweeping the floor and debris into the large fireplace at the lake end of the building. It seems the slanted portion of the floor, not present until this time, was used to sweep debris into the fireplace for burning. The benches in the background are the same benches which are still used in the Lodge today.

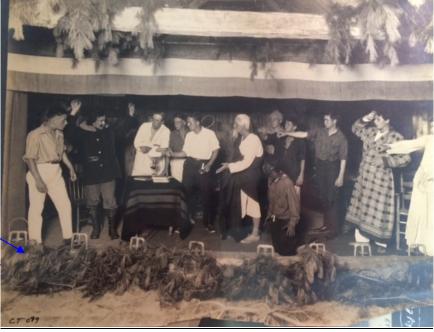
Figure 14: Theatre comes to the Lodge, CT099

Pine boughs and kerosene lamps. FIRE HAZARD!

*The arrival of Ralph and Walter Johnson in 1916 brought theatre to the camp and the Lodge was used as the theatre space.

*Skits and musicals were performed every Saturday night with kerosene lamps burning because there was no electricity, and the rafters were adorned with pine boughs. It's a wonder the place didn't burn down!⁵

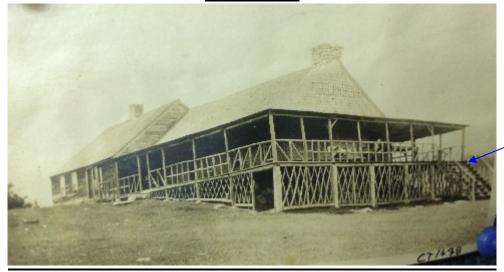
Figure 16: 1910 view of Lodge, stairs facing lake, CT1638

Stairs facing lake

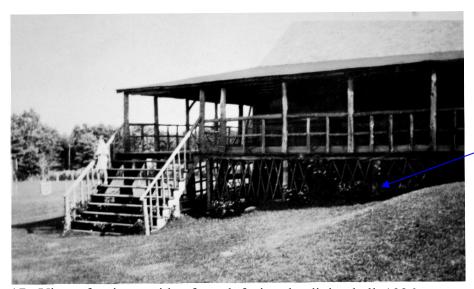
Figure 17: View of stairs on side of porch facing the dining hall, 1926, un-numbered

Stairs now facing dining hall

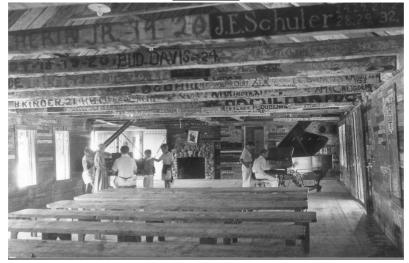
Figure 18: 1933, Interior of Lodge, campers names and pianist, un-numbered

*The tradition of each camper writing their names on the walls and rafters of the Lodge began in the nineteen teens. This photograph shows the number of campers that had attended camp since then and how they already seemed to be short on room.

*The oak floor that is currently in the Lodge was laid in 1934 by Clint Grace, a skilled farmer. He followed the pattern of the floor when the original farmhouse floor was leveled to meet the Poor Farm. He was also responsible for modernizing the widdow in the mid 1930s.

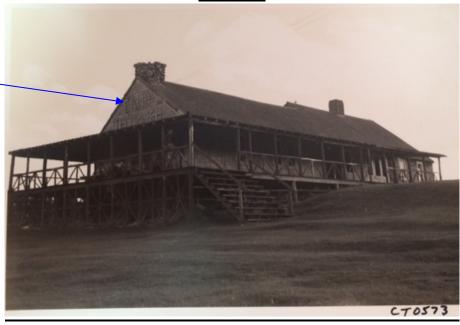
Figure 20: 1940, Exterior view of Lodge, from Dining Hall, CT0573

"CAMP" added to gable

- *First appearance of "CAMP" being added to the gable to read "CAMP TECUMSEH"
- *Stairs are on the right side of the building
- *Railing patterns have changed for the first time since their construction:

*Pattern present on all upper railings, all three sides

*Pattern over Poor Farm cells

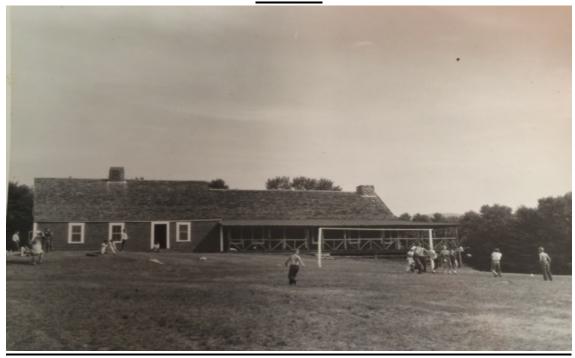
Figure 22: View from playing field, CT0641

- *Molding around all windows and doors whitewashed c.1940-50 $\,$
- *Re-shingling of roof done by David Spooner, an original Trustee, while camp in session
- *Playing fields surrounding the Lodge highlights central importance to camp and activities

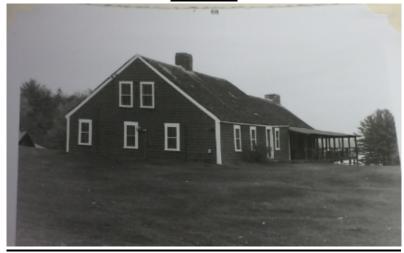
Figure 24: Photo from 1961 appraisal form

*From appraisal by Arthur F. Solomon:

Style of house: Cape Cod Post and beam construction 2600 square feet of porch space

Foundation dry rubble masonry, partial cellar with dirt floor

Remainder of house (addition) standard framing

*Asymmetrical pattern of windows on original farmhouse facing road, trim and molding painted on all sides

*Shingles on building have been replaced over the years and at some time (unknown) painted red

*Repairs and additions on the Lodge since the nineteen-teens is evident

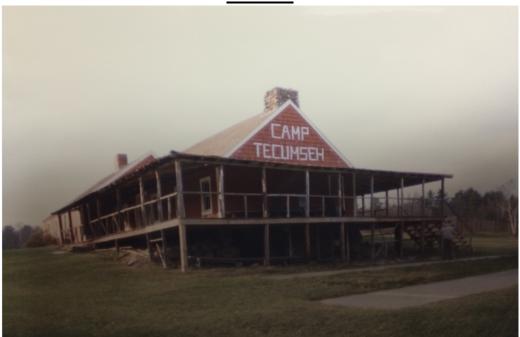
Figure 26: Exterior of Lodge, 1974, un-numbered

New roof

New clapboards

Complete overhaul of foundation

Beams and plaques preserved

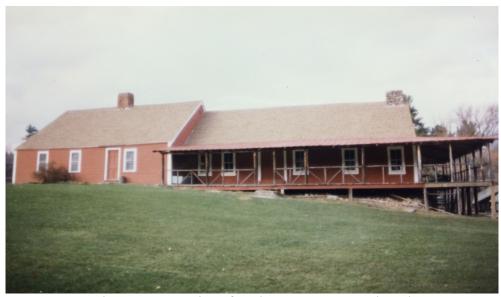
Figure 27: Exterior of Lodge, 1974, un-numbered

^{*}Restoration of Lodge building started in August 1976
